FINAL REPORT

PROJECT ADC/73AD/62-29

A/P22S-3 SUIT CONTROLLER 296, 579

9 JANUARY 1963

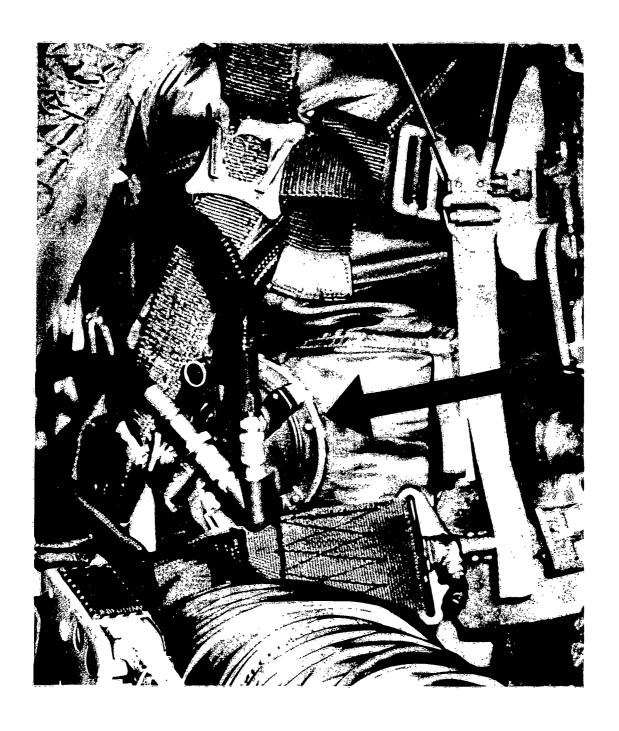
Figure 1

- 1. During previous tests conducted by the 4750th Test Squadron, it was discovered that interference existed between the B-5 parachute harness and the suit controller of larger size A/P22S-3 full pressure suits. During Project ADC/73AD/61-19, Hypoxic Warning Device, one aircrew member had a "Breko" fitting broken from the suit controller by his parachute harness. This break stopped the flow of oxygen for breathing and for suit inflation. This deficiency was brought to the attention of ADC and ASD. ASD proposed the following fix to alleviate the interference:

Figure #1 shows interference between B-5 harness and suit controller before using higher than average index numbers to size adjust harness. Suit controller shown has not been rotated. Suit size is Medium Large Long.

- 13. It is recommended that:
 - a. ADC accept the ASD proposed fix.
- b. The B-5 parachute harness be adjusted using higher than average (at least one digit) index numbers when used with A/P22S-3 full pressure suit.
- c. The suit controllers for A/P22S-3 full pressure suits be rotated 60 degrees (one mounting screw hole) clockwise.
